Beware the Zinc Whiskers

Barry Elliott RCDD belliot@capitoline.co.uk

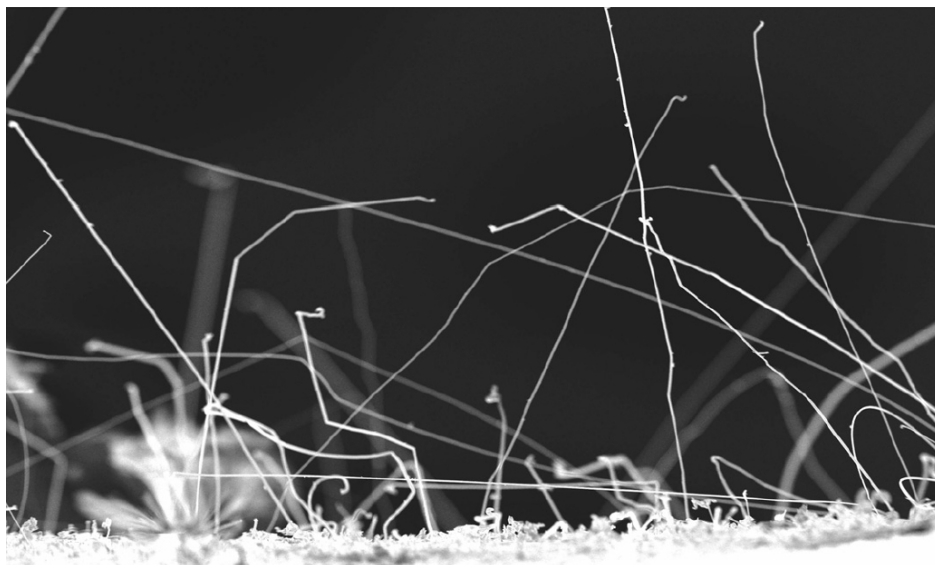
Photo: Zinc whiskers, approximately 1 mm long. Courtesy NASA

It is not clearly understood why the zinc atom structure begins to separate from the steel and pushes the zinc coating away from the steel surface. The whisker growth occurs from the base and the result of this separation is tiny zinc columns that are pushed or grow away from the surface.

The whiskers grow at a rate of about 250 microns per year and have a uniform diameter of about 2 microns. The whiskers can reach lengths of up to 1 cm and can become potential problem to electronics when they reach a length of 500 microns or half a millimetre.
